National Aeronautics and Space Administration

Trains Collide at Ladbroke Grove

(A Lesson in Human Factors Design)

Leadership ViTS Meeting

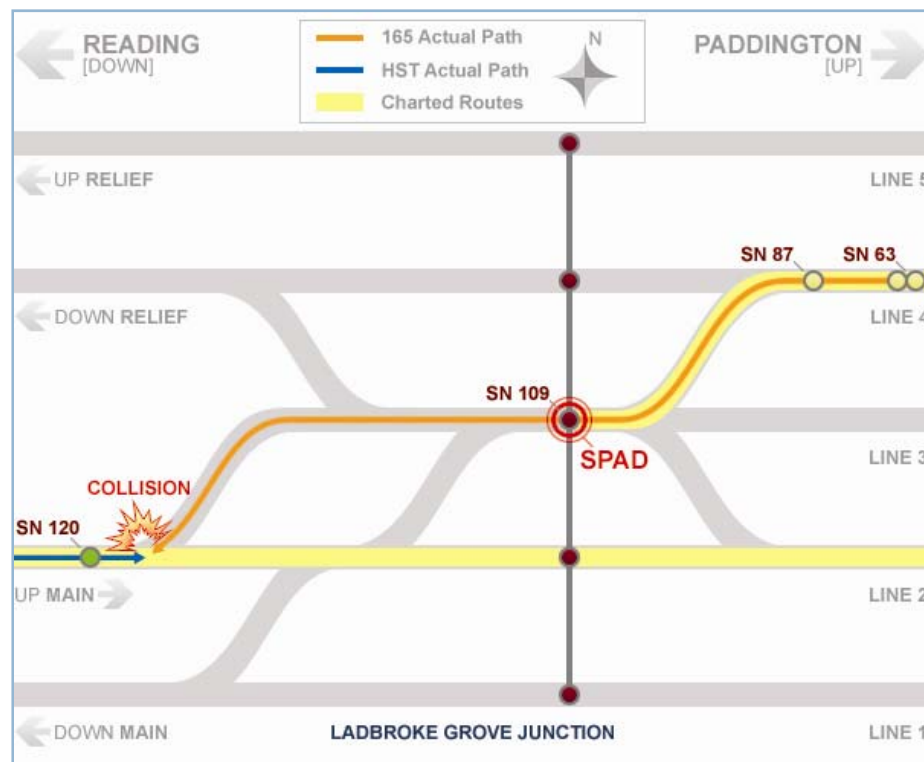
Track Diagram

Position of 165 Train	Action taken by the 165 Operator
SN 63: Double Yellow (AWS horn sounds)	Cancels AWS horn; applies brakes
SN 87: Yellow (AWS horn sounds)	Cancels AWS horn; coasts
239 Meters Before SN109: signals for all the tracks except the 165's (SN109) are visible. All the signals are red.	Applies power
107 Meters before SN109 (AWS horn sounds)	Cancels AWS horn; increases power
SN109: Red	Continues to accelerate: SPAD
100 Meters Before Collision: oncoming HST is visible	Applies emergency brakes
Collision: the 165 collides with the approaching HST with a closing speed of approximately 130mph

- The gantry was frequently obscured by transverse girders and overhead line equipment.
- SN109 was visible 60 meters after the other signals on the gantry.
